RE: **Asbestos Survey Report
Former Federal Reserve Bank
1015 Second Ave
Seattle WA 98104
(Project # GSANW30630)**

Asbestos Survey Report

**Former Federal Reserve Bank
1015 Second Ave
Seattle WA 98104**

Project No. GSANW30630

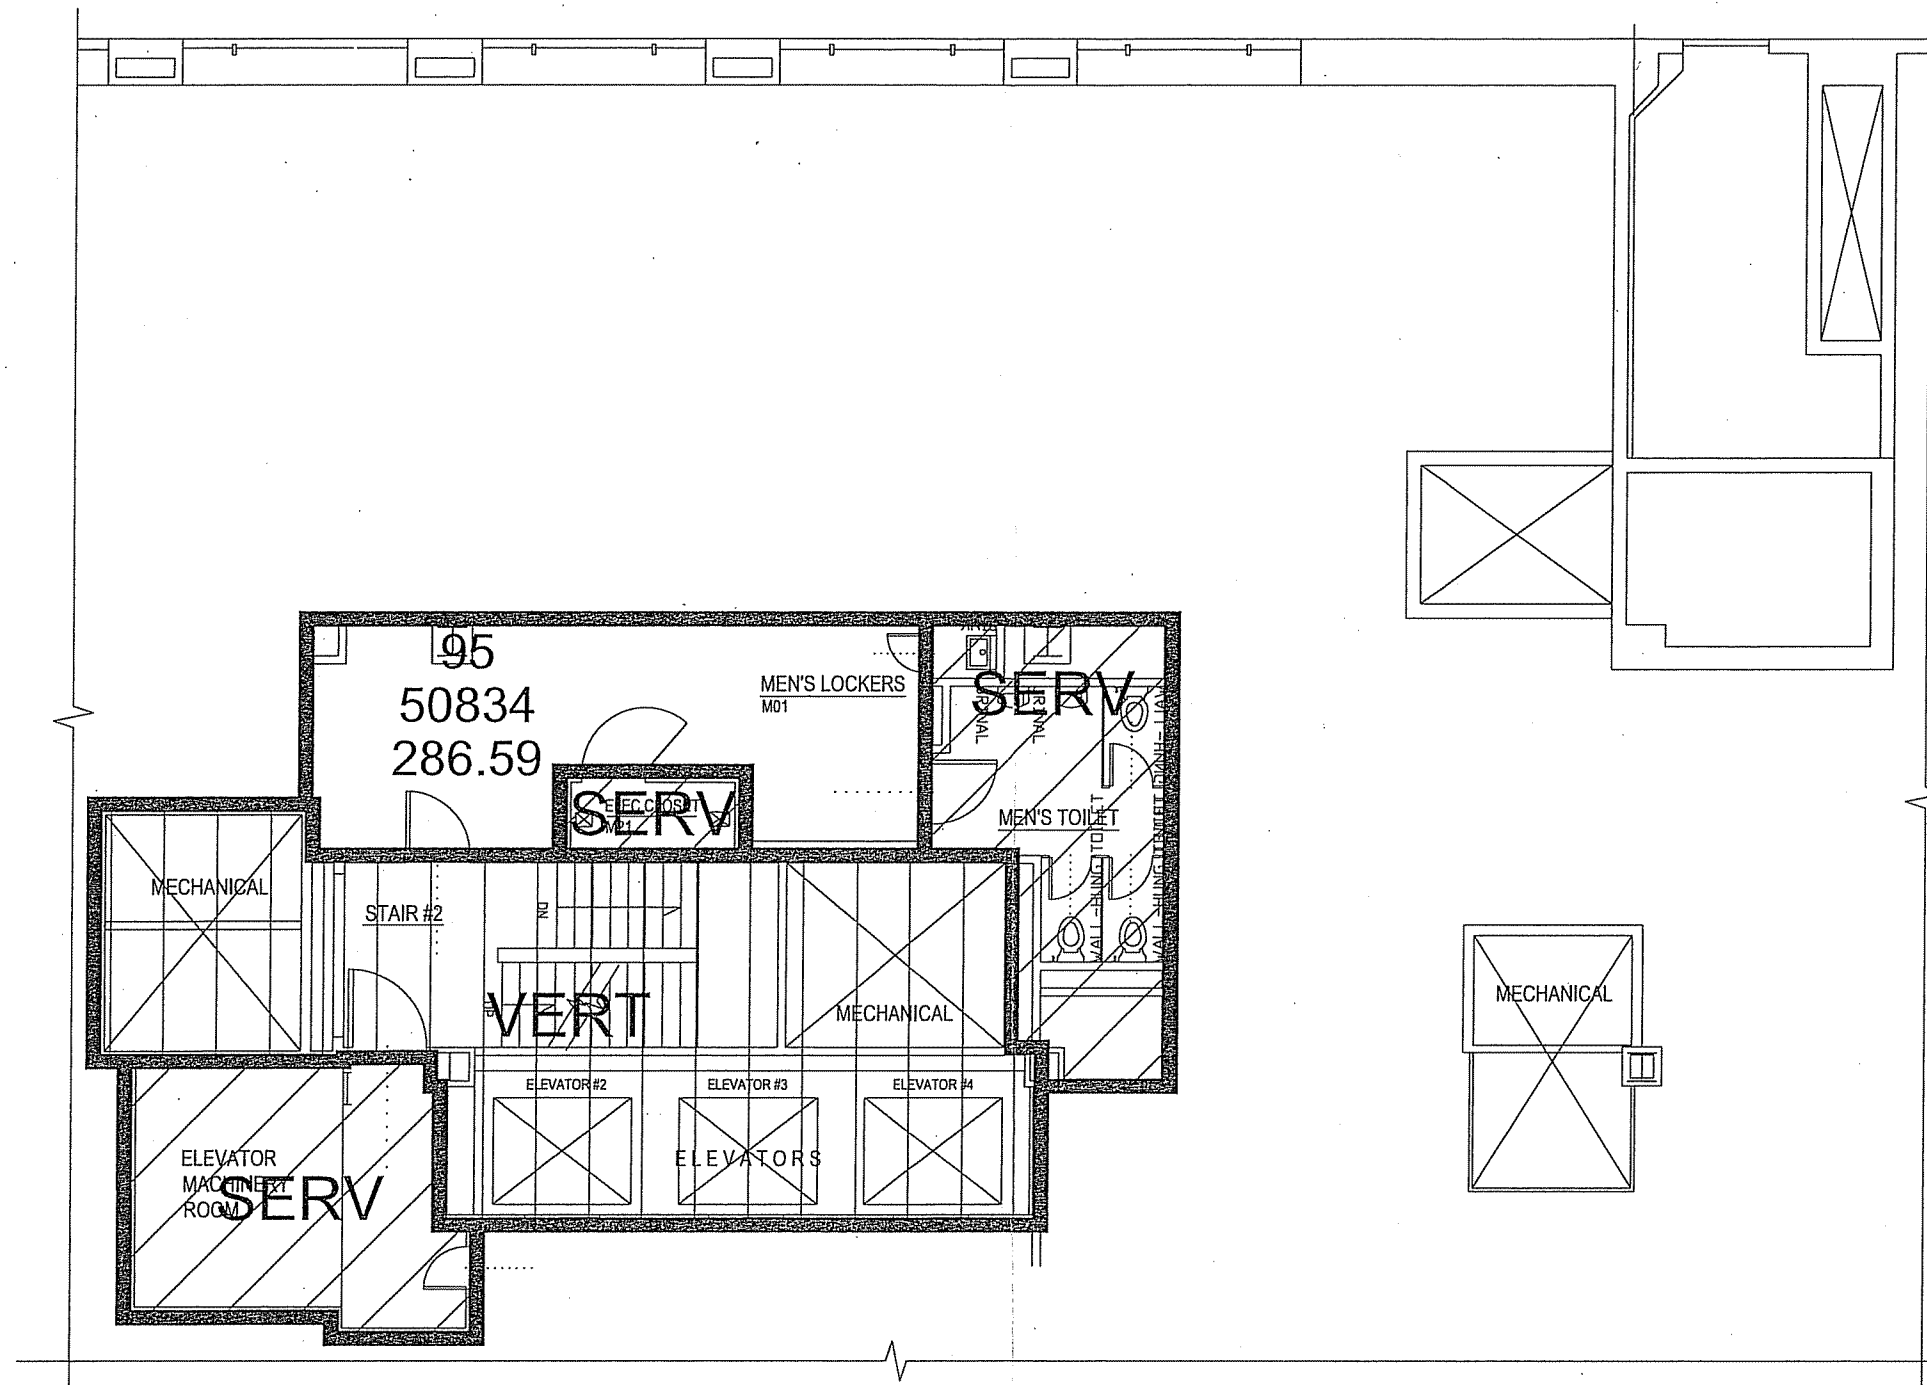
Area of
Seismic
Retrofit
(1995)

The building located at 1015 Second Ave is a 4 story building with a penthouse and two basement levels. The former Federal Reserve building consists of a concrete foundation with sandstone and marble exterior cladding. Structural walls are steel frame. Interior finishes are CMU block, brick, plaster and gypsum wallboard walls, with vinyl floor tile, carpet, ceramic tile or bare concrete floors. Floors 3 and 4 were completely remodeled and sections of all other levels were remodeled since the previous survey performed in 1993 by Environmental Control Science, Inc. Areas of seismic and structural reinforcement are noted on the attached sample location drawing.
